# WIRE ROPE

# **What we can learn from wire rope failures: Predictable and unpredictable rope failures**

by Dipl.-Ing. Roland Verreet

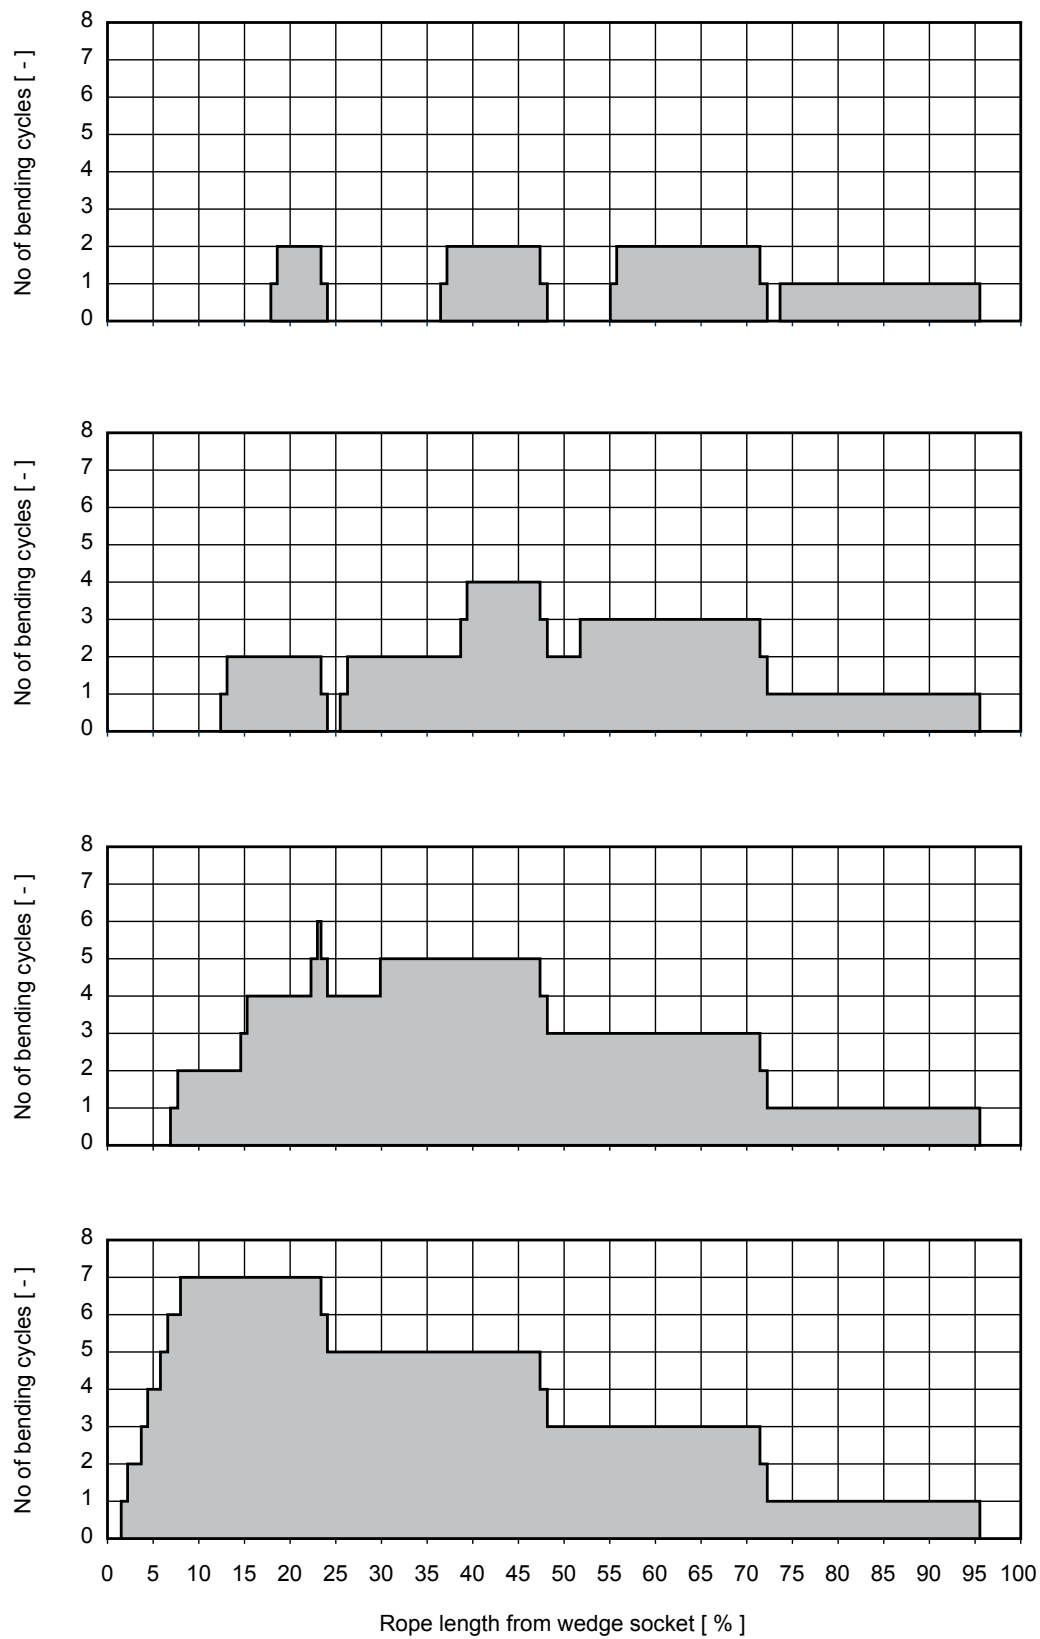
Figure 1 shows the bending fatigue distribution per lifting cycle (1×lifting, 1 × lowering) of four different 4-part overhead cranes which always lift loads from the ground to 25%, 50%, 75% and 100% of the maximum lifting height, respectively.

If the rope of the second crane will not be taken out of service in time, it will one day fail at about 40 to 46 m away from the wedge socket.

If the rope of the fourth crane will not be taken out of service in time, it will one day fail at about 8 and 24 m away from the wedge socket (on the so-called “dead” fall).

Fig. 1: The bending fatigue distribution per lifting cycle (1 × lifting, 1 × lowering) of four different 4- part overhead cranes.

Reeving systems which repeat the same operation over and over again are critical with respect to the rope inspection. If, e.g., the rope of the first crane shown in Fig. 1 is always inspected at 10m and 30m away from the wedge socket (because these rope sections are maybe more accessible than others), an increasing rope deterioration at 20 m, 40 m and 60 m will never be detected. Then one day the rope will fail, e.g. at 20 m, without the inspector having detected one single wire break before.

This alone would not be a major problem. The rope deterioration could be detected during a proper rope inspection. But most rope inspectors think that the slowly travelling "dead" fall will not be subjected to a great amount of fatigue. They will therefore preferably spend their time inspecting the "fast" falls where (as the fourth crane in Fig. 1 shows) much less fatigue damage is accumulated.

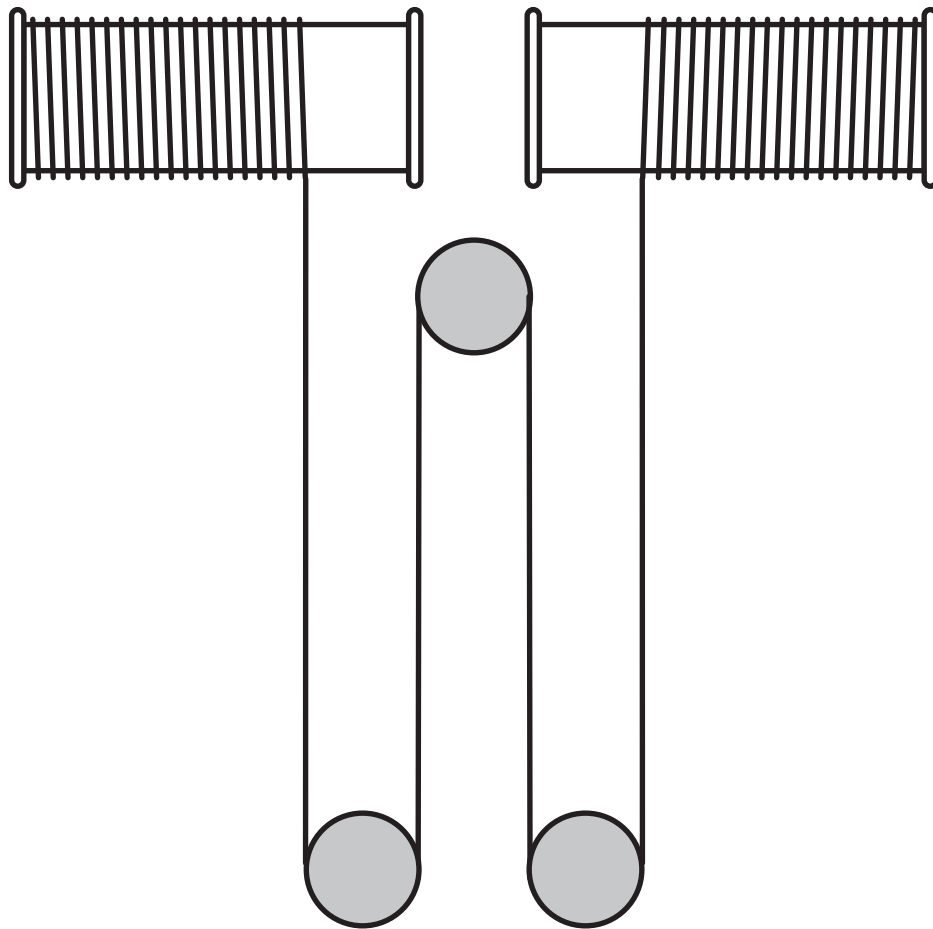
The two points of entry into the equalizer sheave in overhead cranes are the single most critical locations for a steel wire rope failure on cranes. Fig. 2 shows a schematic drawing of a twin drum crane with such an equalizer sheave.

Fig. 2: Schematic drawing of a twin drum crane with an equalizer sheave (the middle, smaller sheave).

During a typical lift, these two sections at the equalizer sheave will not be subjected to a bending cycle. That is why crane designers think they should be allowed to make the equalizer sheaves smaller than the other sheaves in the reeving system.

During the crane travel between lifting the load and lowering it again, however, the load will swing under the crane bridge. This load swing will force the critical sections to continuously enter and leave the equalizer sheave and thereby subject them to great number of bending cycles.

The fact that the equalizer sheave is often smaller in diameter than the other sheaves in the reeving system increases the amount of fatigue damage in this area, and the fact that the equalizer sheave is often the least accessible sheave makes the detection of a coming rope failure in this location even more unlikely.

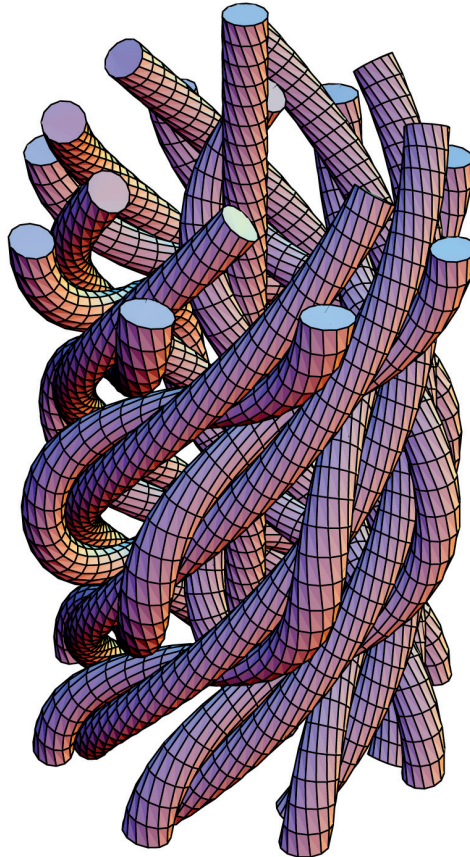
Fig. 3 shows 14 of the 49 wires of a simple rope design ( $7 \times 7$ ). In such a rope one

centre wire is straight, 12 wires form helix and 36 wires form a helix around a helix. If this rope was lengthened by, e.g. 1 cm, the straight centre wire would have to get 1 cm longer whereas all other wires would adapt to the new length by partly stretching and by partly simply changing their angle. The helixes would normally stretch more than the double helixes.

Fig. 3: 14 of the 49 wires of a simple rope design ( $7 \times 7$ ).

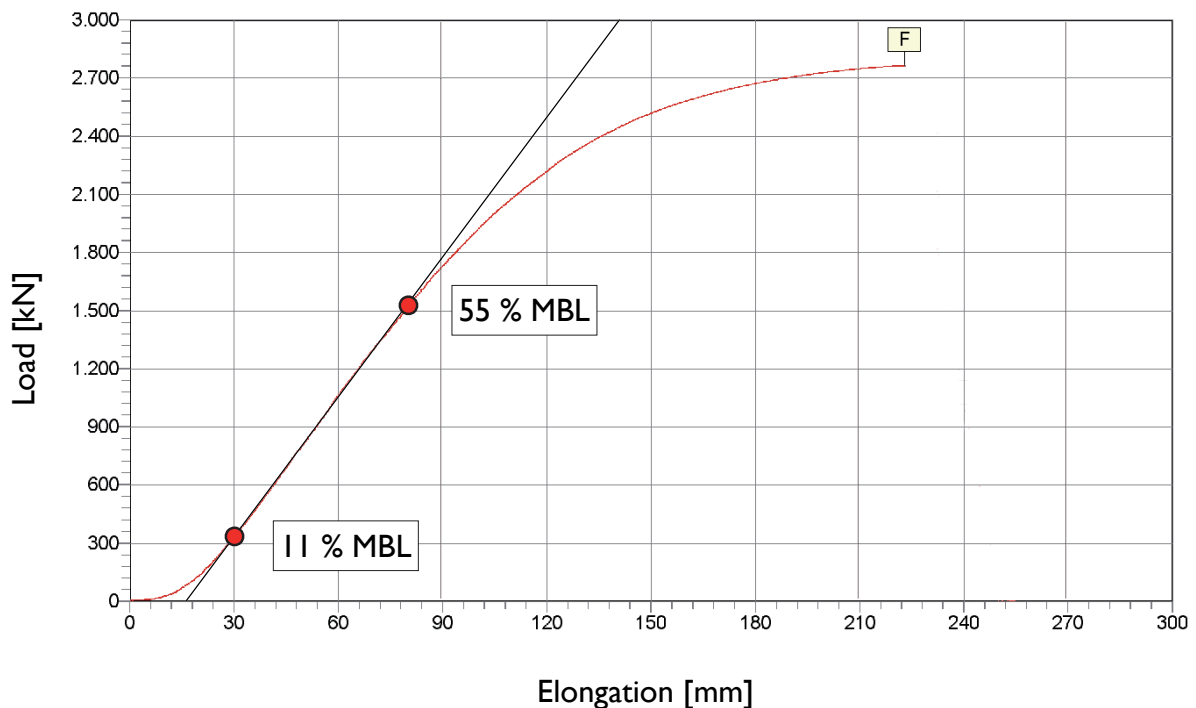
In a typical wire rope the load-elongation chart (Fig. 4) is characterized by a non-linear zone where the shorter elements carry the greatest amount of the rope load (0% of the minimum breaking strength to about 11%), a linear zone where all rope elements share the load (about 11% of the minimum braking strength to about 55%) and another non-linear zone where more and more rope elements yield (about 55% of the minimum breaking strength until the rope failure).

Fig. 4: Typical wire rope load-elongation chart.

If the rope is subjected to tension-tension loads lower than about 11% of its minimum breaking strength it will be most likely to fail from the inside out.

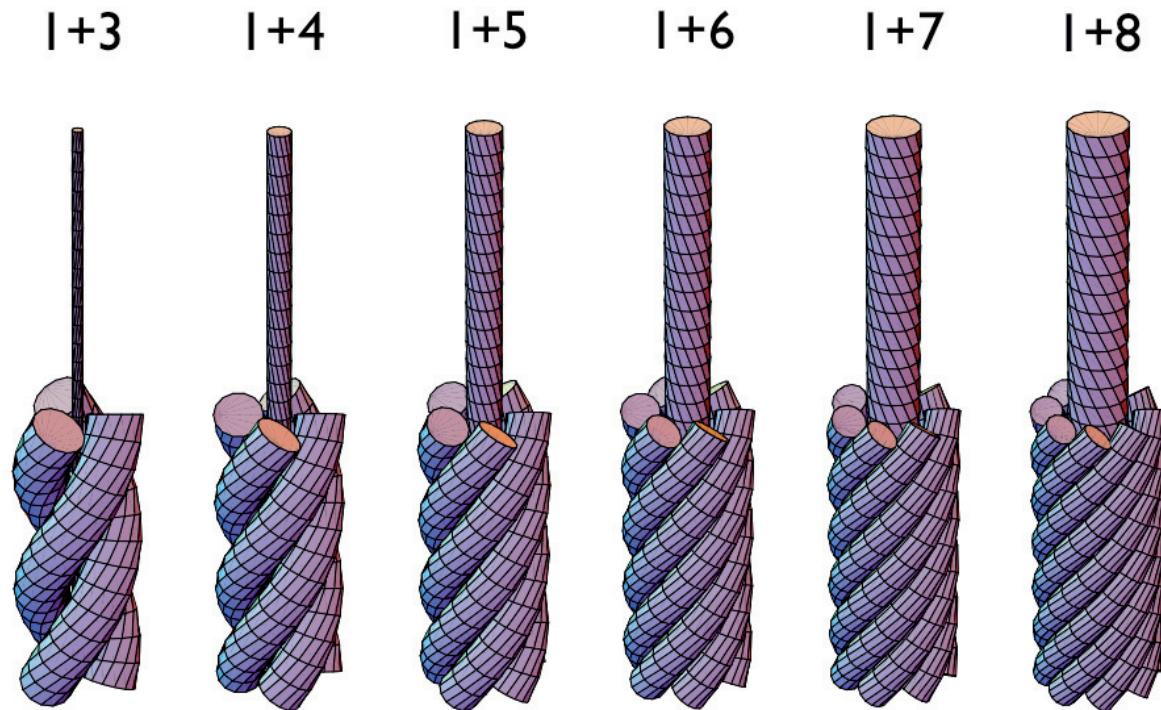
With increasing number of outer strands, the share of the outer strands on the cross section of the rope will decrease and the share of the core will increase (Fig. 5).

Fig. 5: Relationship between the number of outer strands and the size of the core in a rope.

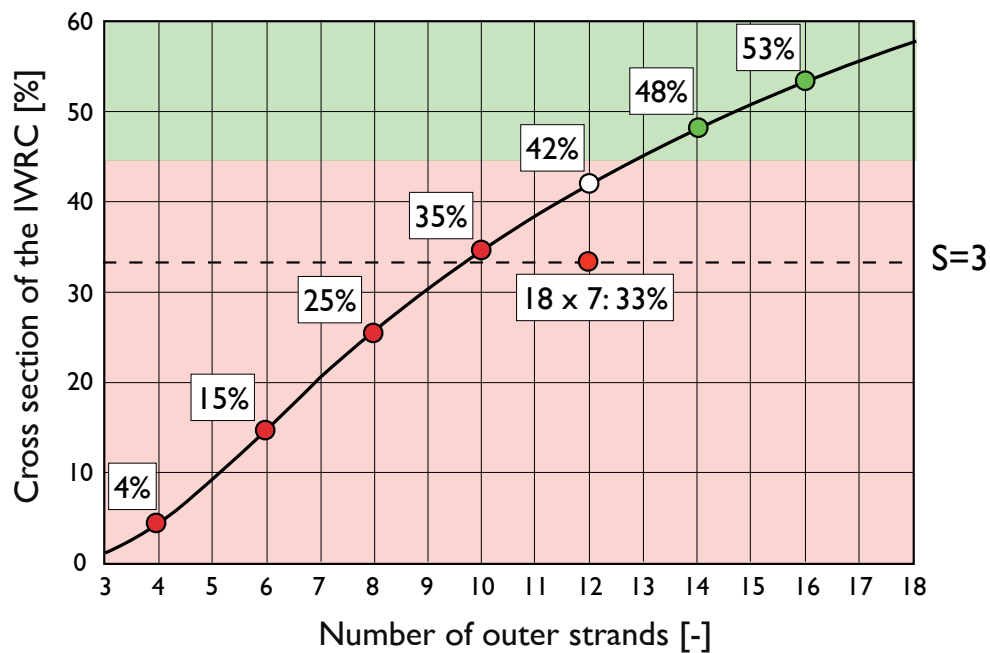
Fig. 6 shows the percentage of the metallic rope cross section represented by the core of the rope.

Fig. 6: Percentage of the metallic rope cross section represented by the core of the rope.

We can make the same reasoning of paragraphs 1.5.1 to 1.5.3 for a case where the design factor is 3, which is the minimum allowed for cranes. This design factor  $S=3$  is also shown in Figure 6. The green dots are safe in the event of a birdcage formation: even with a load of 33% of the MBL, the IWRC representing 48% or 53% of the rope cross section will not break. The 12-strand rope with 42% might break due to the extra impact load. But the 12-strand rope with only 33% of the cross section in the IWRC certainly will. As will all the other ropes with red dots.

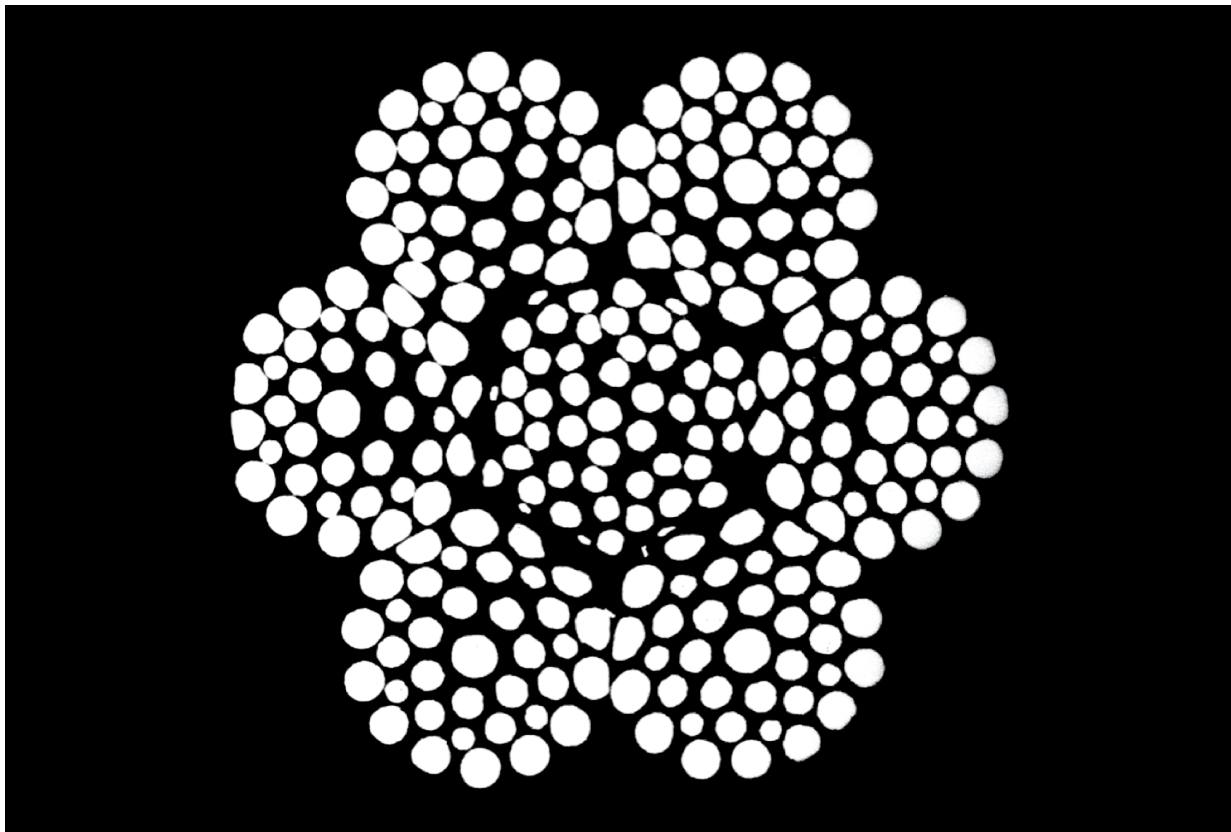
One of the most expensive rope accidents ever happened because a wire rope had corroded internally (Fig. 7). The ungalvanized rope had been manufactured with only little lubrication and then worked as a hoist rope on an offshore platform for several years.

Fig. 7: This rope shows severe abrasion and corrosion inside while the outside looks good.

In order to protect the rope from the corrosive environment, the rope was relubricated externally. The lubricant, however, did not penetrate inside the rope. Therefore corrosion and abrasion could destroy the rope internally, while the outer coating prevented the rope inspector from seeing the problem.

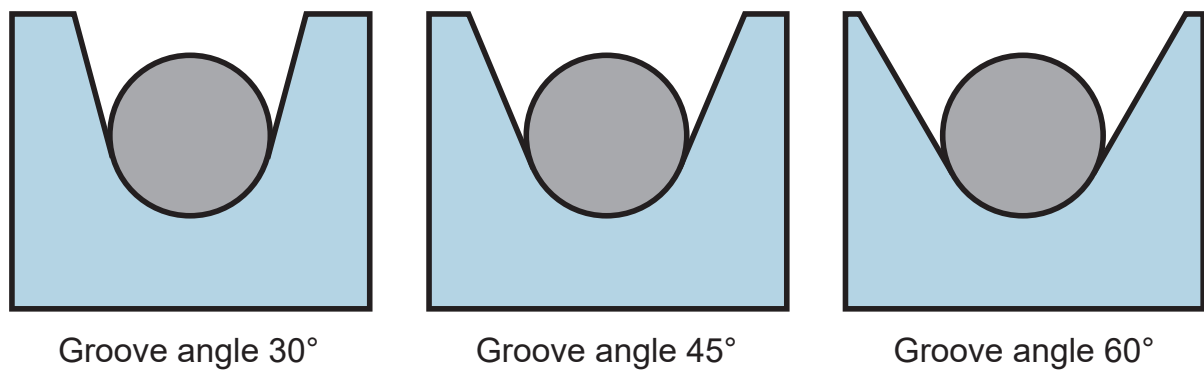
Fig. 8 shows groove angles of 30° (USA), 45° (Germany) and 60° (ISO).

Fig. 8: Groove angles of 30° (USA), 45° (Germany) and 60° (ISO).

In the USA, a rope “jumping the sheave” is more likely than in other countries because of the US Standard requiring a groove angle of 30°.

The German Standard 15061 asks for a minimum groove angle of 45°, and British Standard 6570 requires 52°. In these countries a rope “jumping the sheave” is much less likely. Based on new insights, the newest version of ISO Standard 4308 specifically allows for groove angles up to 60°.

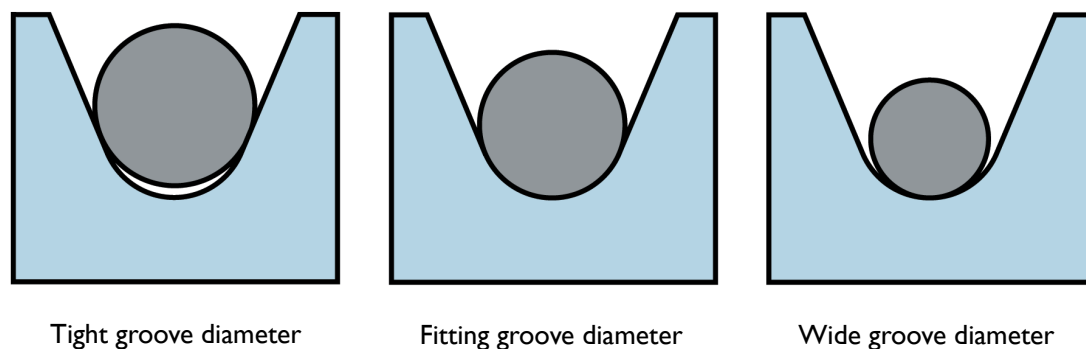
Over the last years, the author has analyzed many accidents caused by ropes which had “jumped the sheave”. In retrospect he found that in most cases the groove diameter in the sheave was much greater than the rope diameter (Fig. 9 right).

Fig. 9: Schematic diagram showing different size ropes sitting in a groove (of the same diameter in each case).

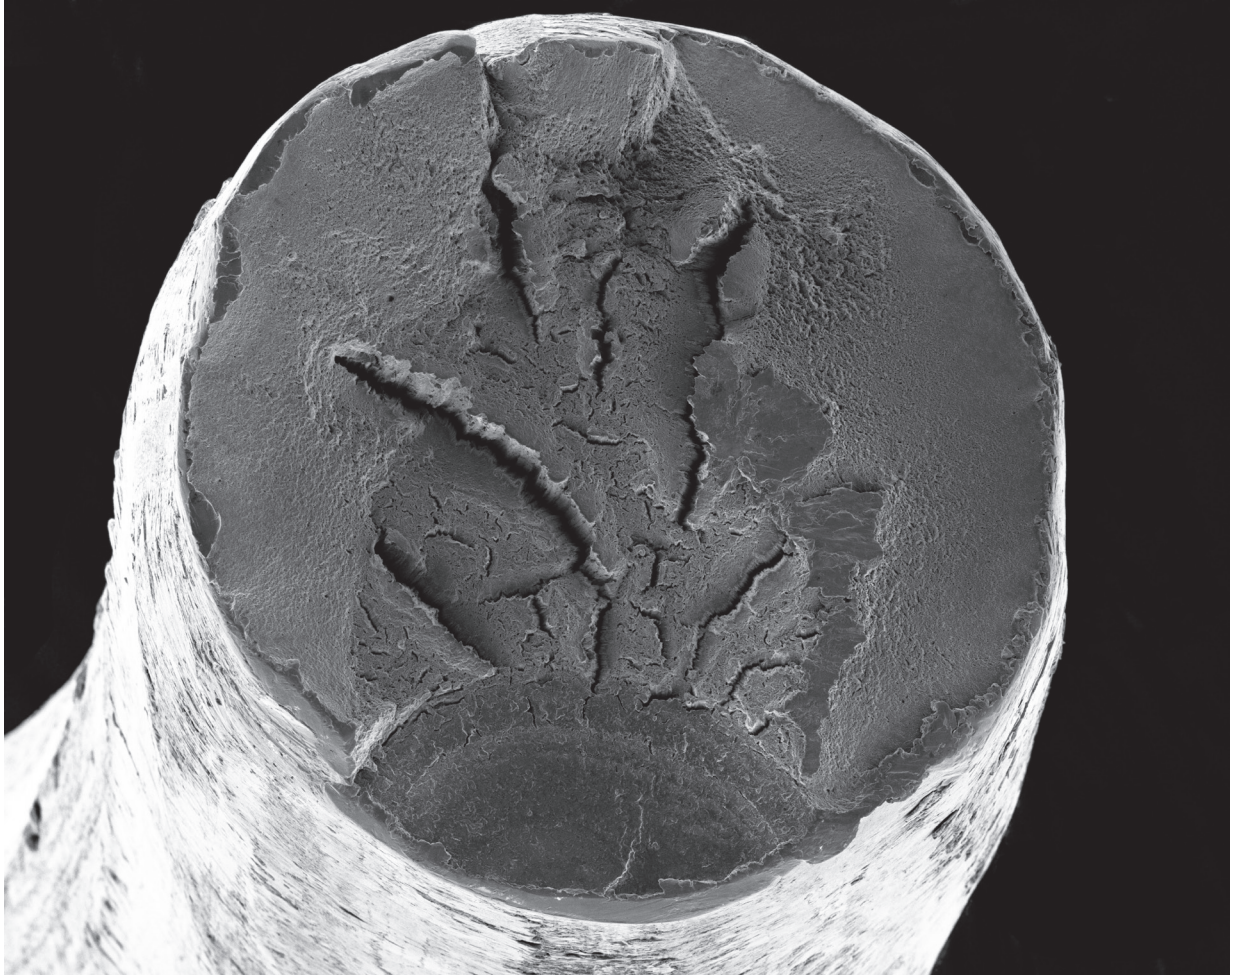
Fig. 10 shows a typical outer wire break surface from a rope which had “jumped the sheave” (scanning electron microscope photograph by the author).

Fig. 10: Typical outer wire break surface from a rope which had “jumped the sheave” (scanning electron microscope photograph by the author).

The fact that the groove had been too wide for the rope increased the bearing pressure on the fewer outer wires in contact with the groove. Therefore a fatigue break was initiated at the bottom of the break surface.

At the bottom of the break surface in Fig. 10 the flattened band along the break was caused by the rope rolling back and forth to the sides in the wide groove.

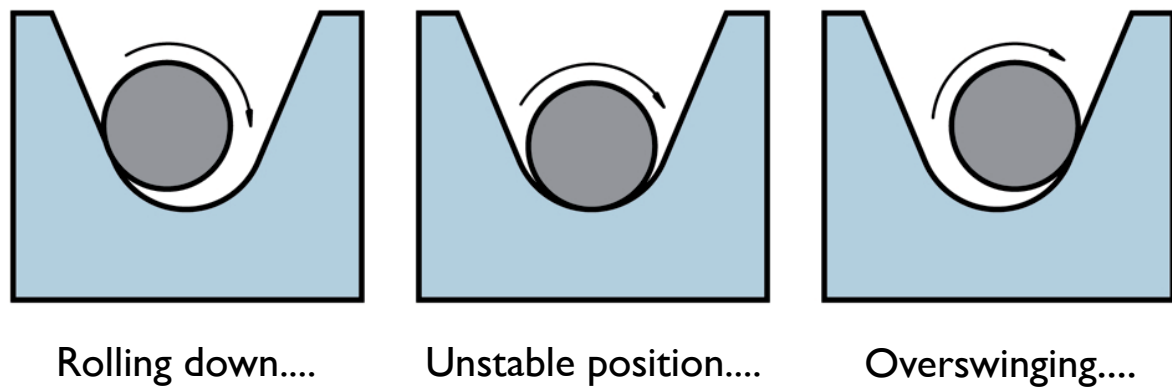
The (lentil- shaped) fatigue area then propagated further into the wire cross section until a much bigger residual break surface was created by the catastrophic event. Because the rope was not held firm to the left and to the right after entering the sheave (as it would have been in a tight or well-fitting groove), any rope vibrations or oscillations outside the sheave could cause the rope to roll back and forth in the wide groove and gain momentum for the “final jump” (Fig. 11).

Fig. 11: Schematic diagram showing how rope vibrations or oscillations outside the sheave could cause the rope to roll back and forth in a wide groove and gain momentum for the “final jump”.

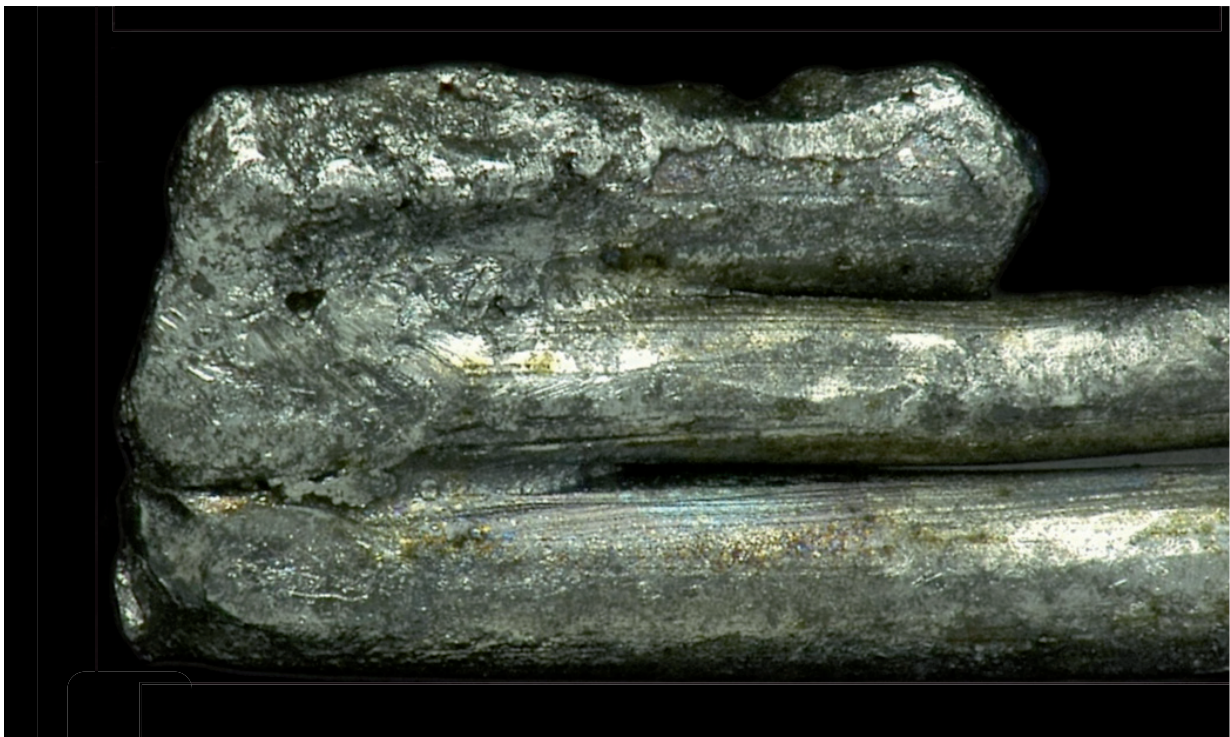
Fig. 12: Individual rope wires welded together as a result of lightning strike discharge through the rope.

A rope analysis showed that at the location of the break and in two additional locations along the rope individual rope wires were welded together (Fig. 12).

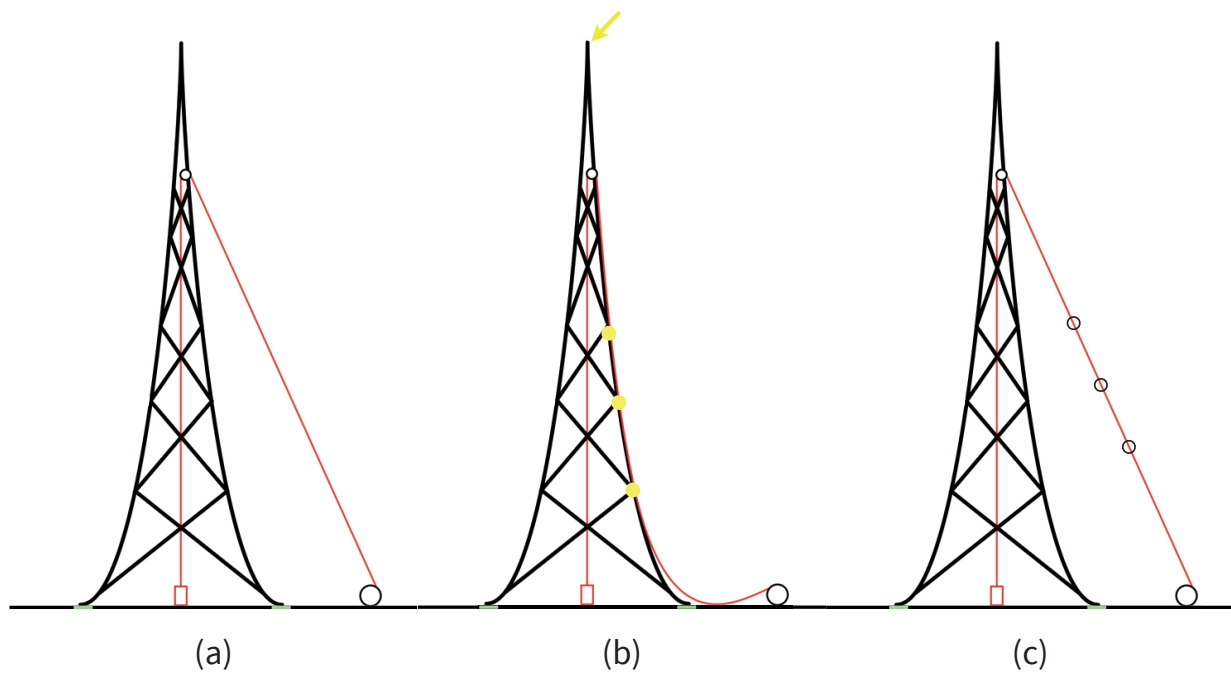
The reeving system of the lift consisted of the man basket, a rope of 9.5 mm diameter, one sheave which was attached to the tower using a nylon sling, and a drum. Fig. 13a shows the man lift in operation.

One night a lightning struck the tower. Because the tower was insulated from the ground, the electricity travelled along the wire rope and the drum (which was the only connection the ground), fusing wires together at the points of contact between the rope and the tower (Fig. 13b).

When the man lift was used again the next morning, nobody was aware of the three rope sections damaged by the lightning strike (Fig. 13c).

Fig. 13: Sequence of events leading to the damage of a man riding basket hoist rope on a radio tower.

A thorough inspection of the whole length of rope performed that very morning would probably have revealed the damage, but the odds were clearly against this.

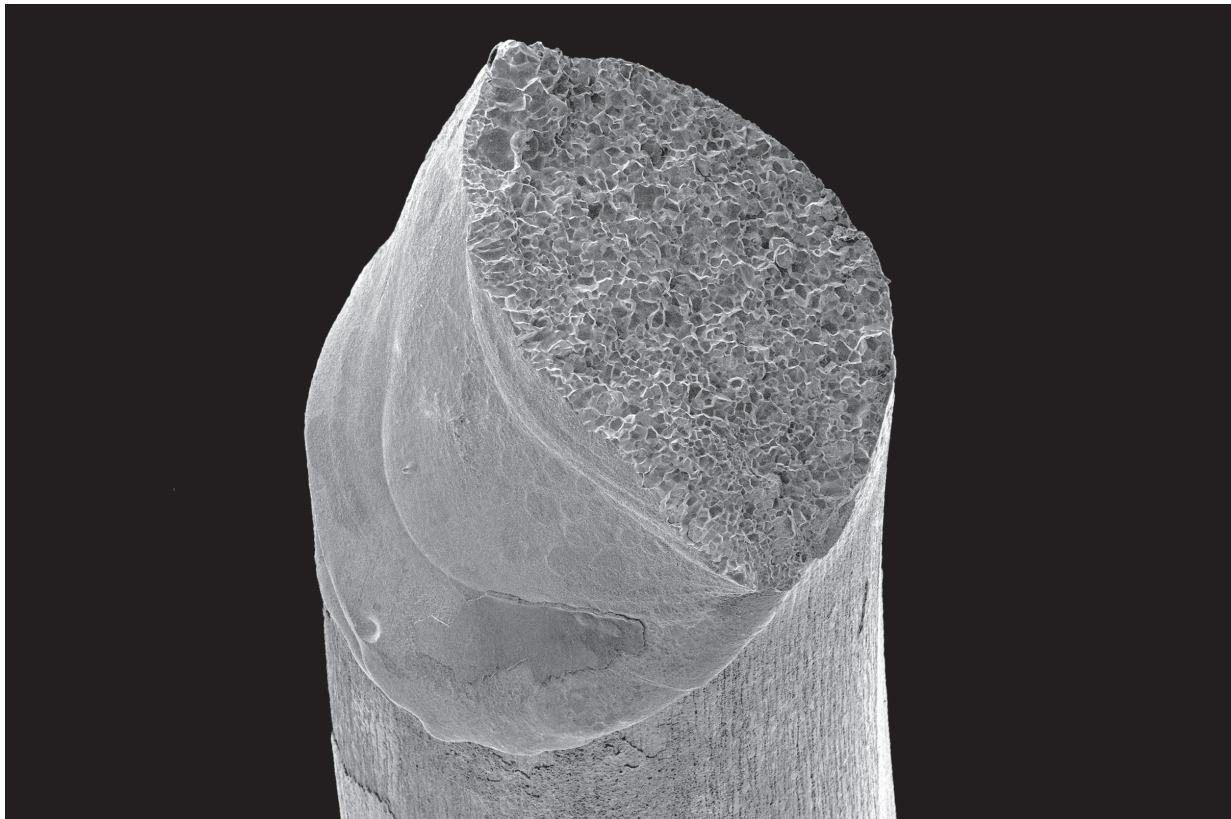
If a rope is struck by lightning, the wire structure will recrystallize (Fig. 14) and the wire will lose about 2/3 of its tensile strength. That is not the main problem, however. If neighbouring wires are fused together, the rope becomes very stiff and the wires will break instantaneously when the rope is bent around a sheave or drum.

Fig. 14: Recrystallized wire micro-structure caused when the rope was struck by lightning.

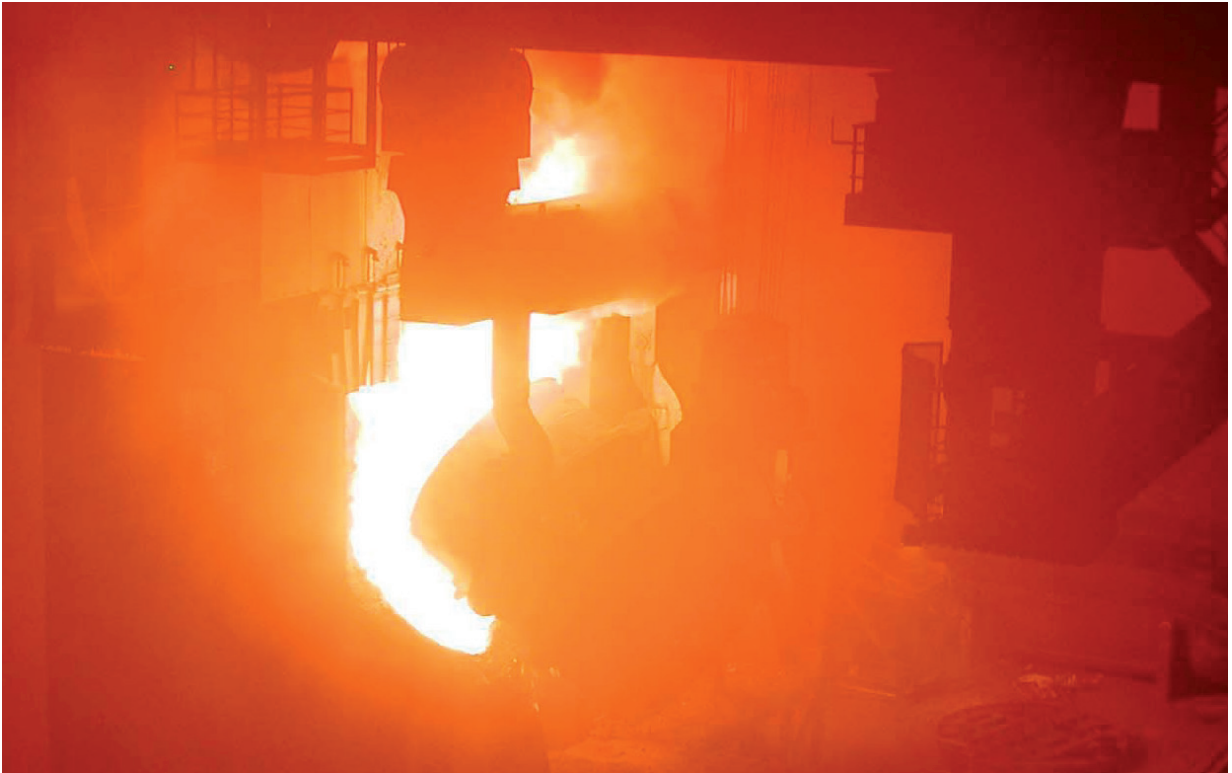
A steel wire rope can operate in a very hot environment (Fig. 15) provided it can conduct the heat it is subjected to to cooler areas of the crane. In Germany, e.g., about 80% of all ladle cranes even operate with steel wire ropes with a plastic layer between the outer strands and the IWRC.

Fig. 15: A steel wire rope operating in a ladle crane in a steel mill.

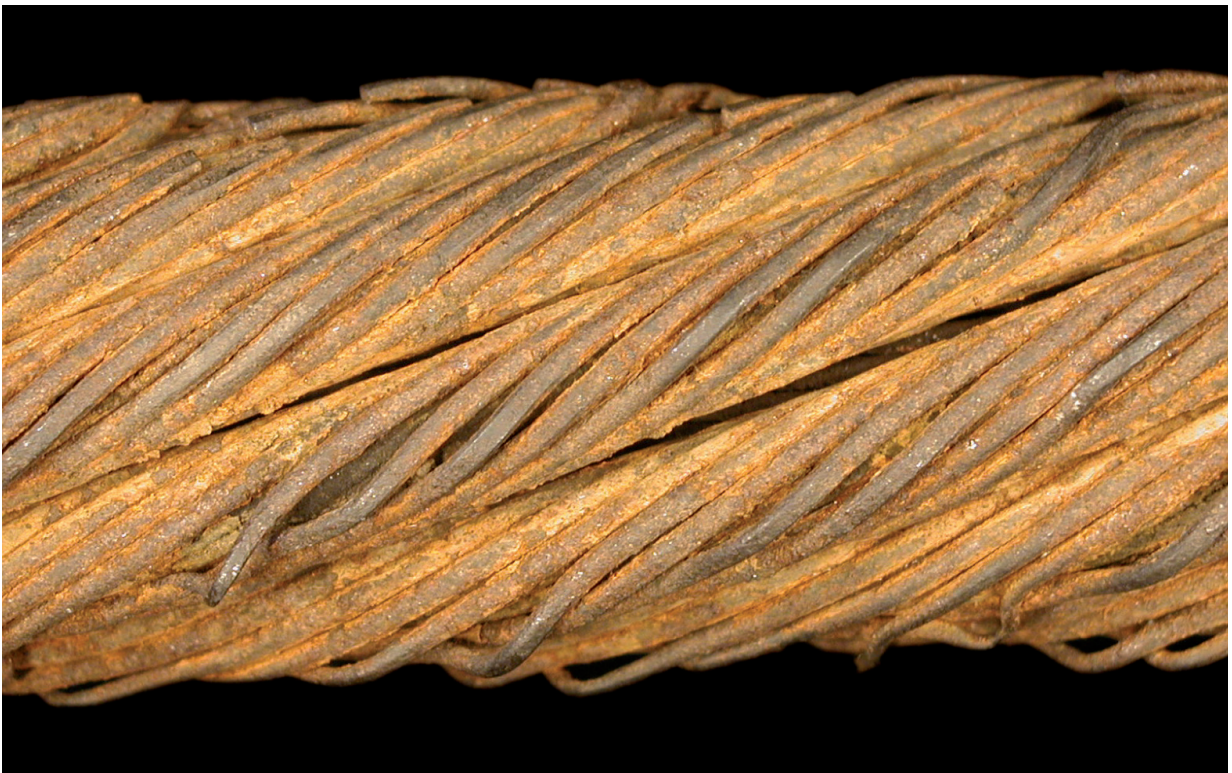
If, on the other hand, the ropes stand in the heat for only a minute too long, the wire material anneals and the rope becomes dangerous (Fig. 16).

Fig. 16: A wire rope in which the wires have become too hot and annealed.

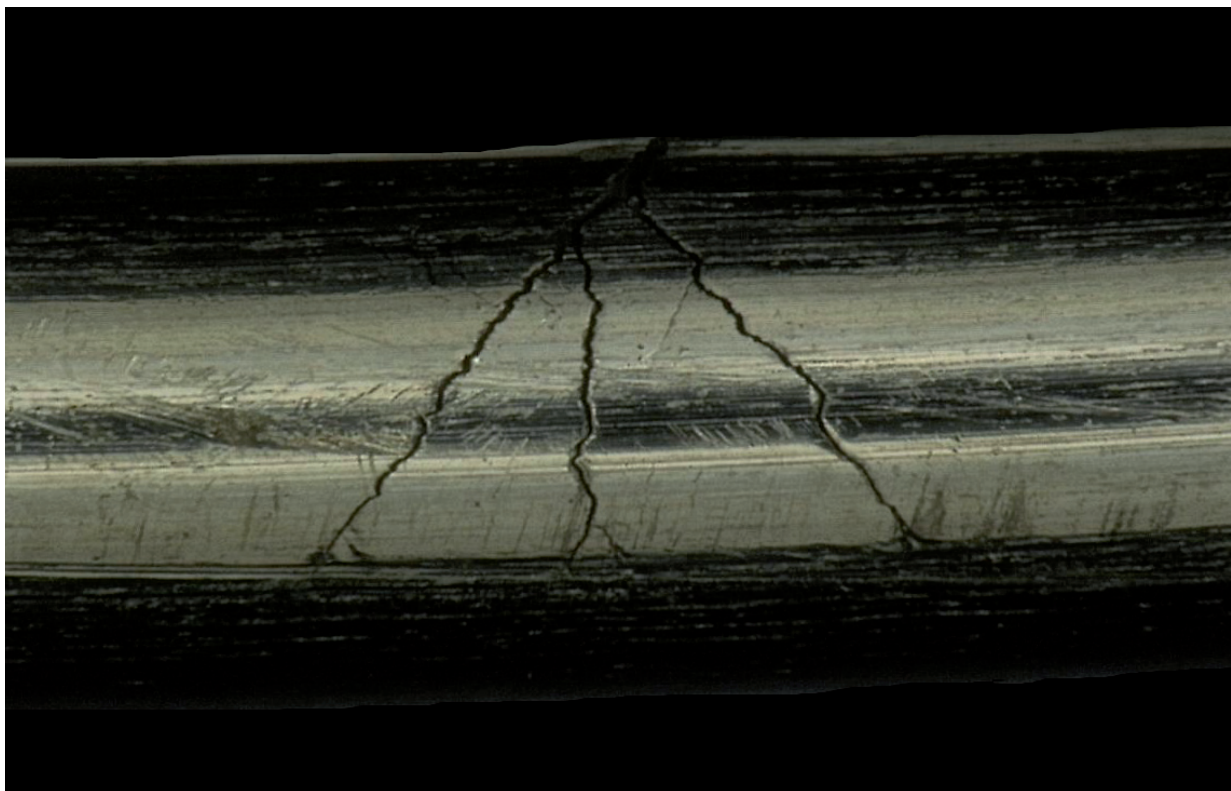
A microscopic analysis of the rope wires revealed a great number of cracks in the vicinity of the point of failure. Along its length every crack had split up in two cracks which a little bit further had split up again (Fig. 17).

Fig. 17: Cracks in a stainless steel wire in the vicinity of the rope failure.

When asked about a possible exposure of the fall protection rope to chemicals a worker remembered that a pipe transporting hydrogen peroxide had burst near the location of the rope's break. The pipe had been repaired, but nobody had worried about the rope. Hydrogen had diffused into the steel and caused hydrogen embrittlement.

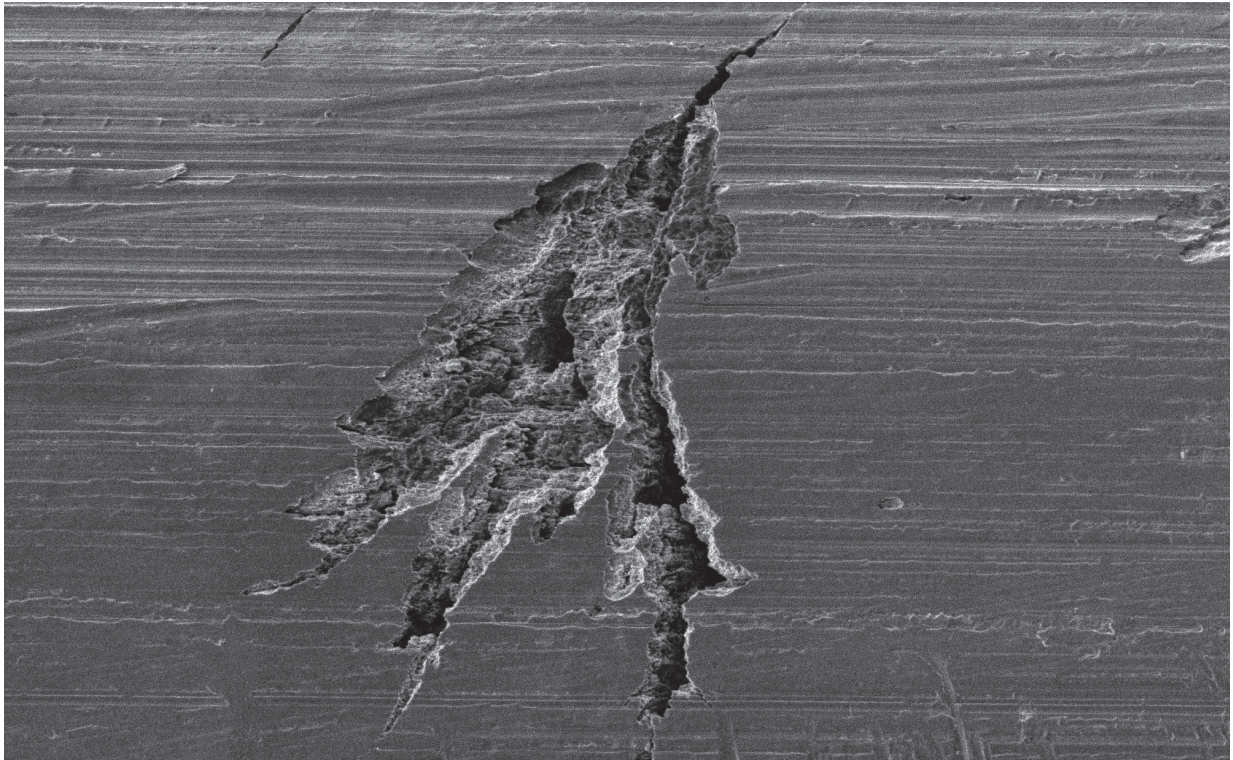
A scanning electron microscopic analysis showed that at every forking point the wire surface had split off as if the material was very brittle (Fig. 18).

Fig. 18: SEM photograph showing apparent material brittleness at every forking point on the wire surface where material had split off.

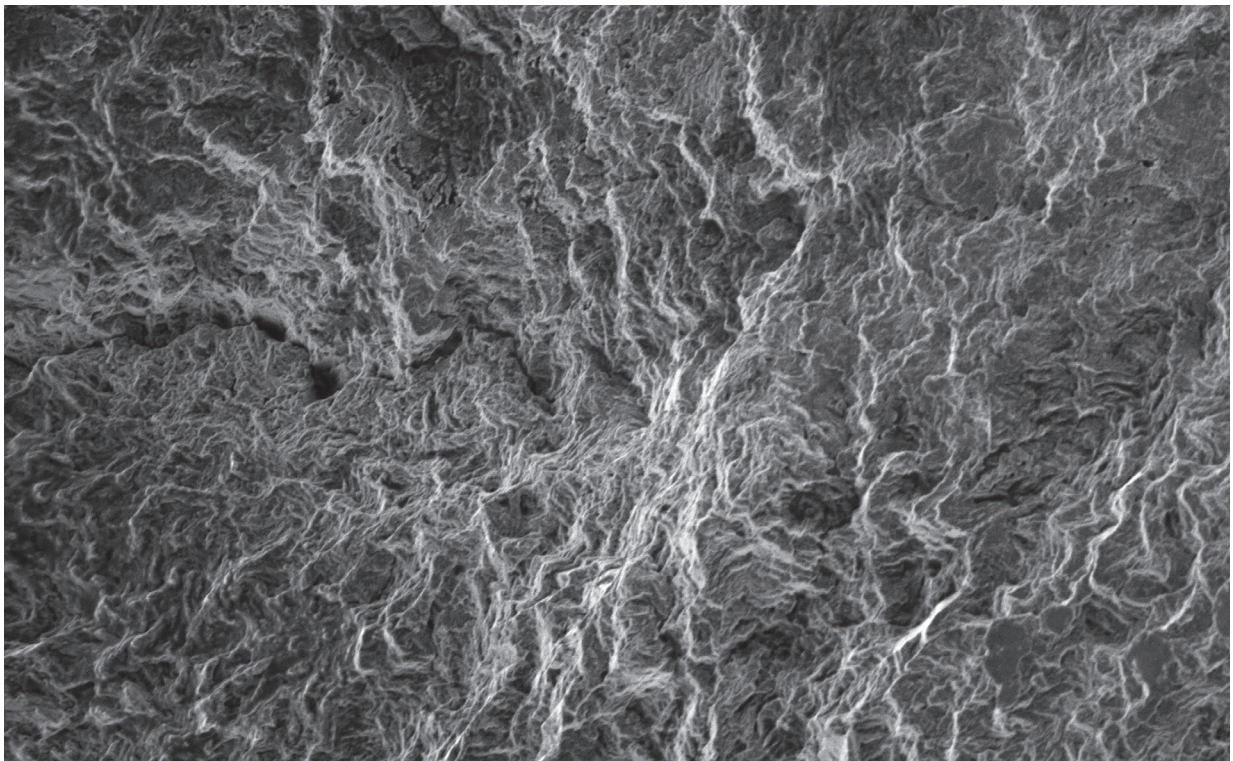
Also at the break ends the wires showed a topography typical for a brittle material and very unusual for a ductile rope wire (Fig. 19).

Fig. 19: Wire break fracture surface showing a topography typical for a brittle material and very unusual for a ductile rope wire.

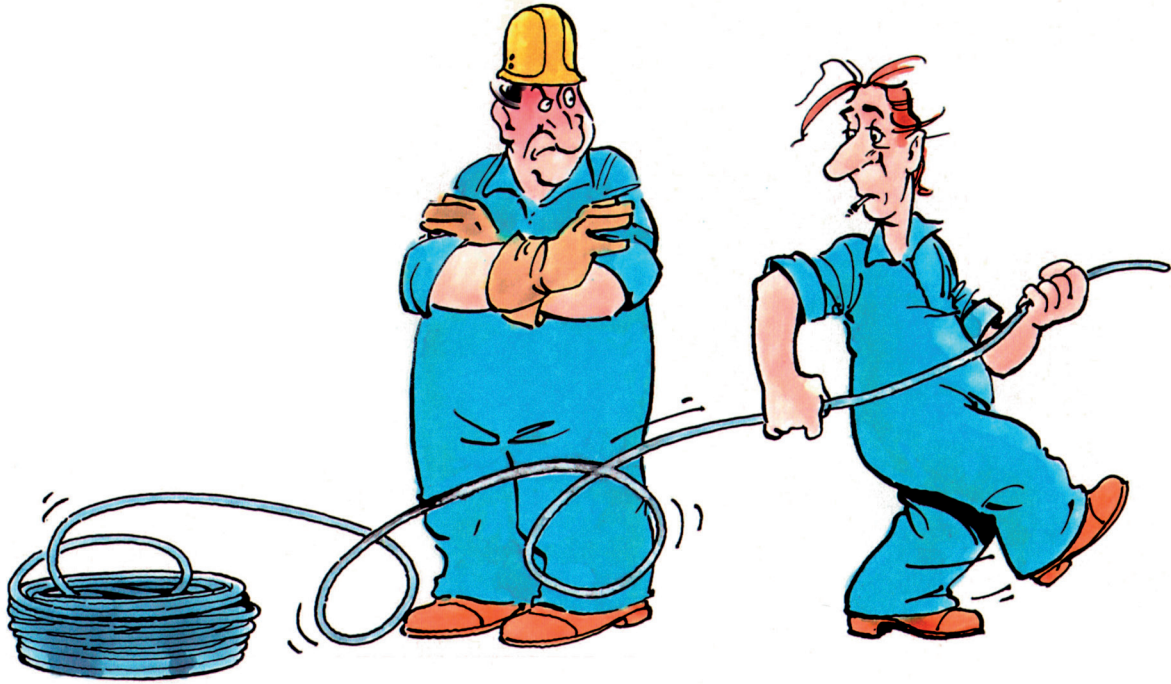
A steel wire rope can be twisted during installation (Fig. 20), or twist can be induced by the machine or the mode of operation of the crane.

Fig. 20: Inducing twist in a wire rope during installation.

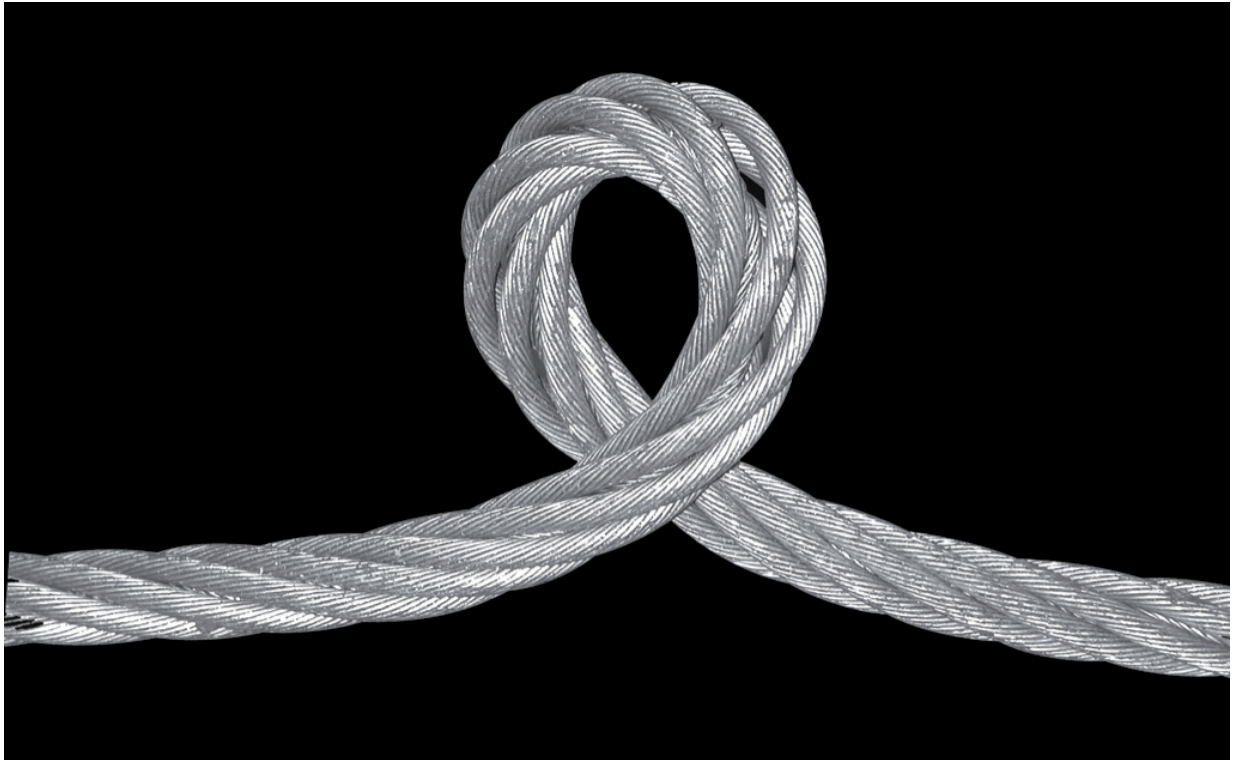
But very often a steel wire rope operates in a twisted condition without the operator ever getting to know about this fact. As long as the rope stays under tension, it might perform well. But if only once the tension is released below a critical value, a kink will form (Fig. 21).

Fig. 21: A kink in a wire rope which is apparent at low tension.

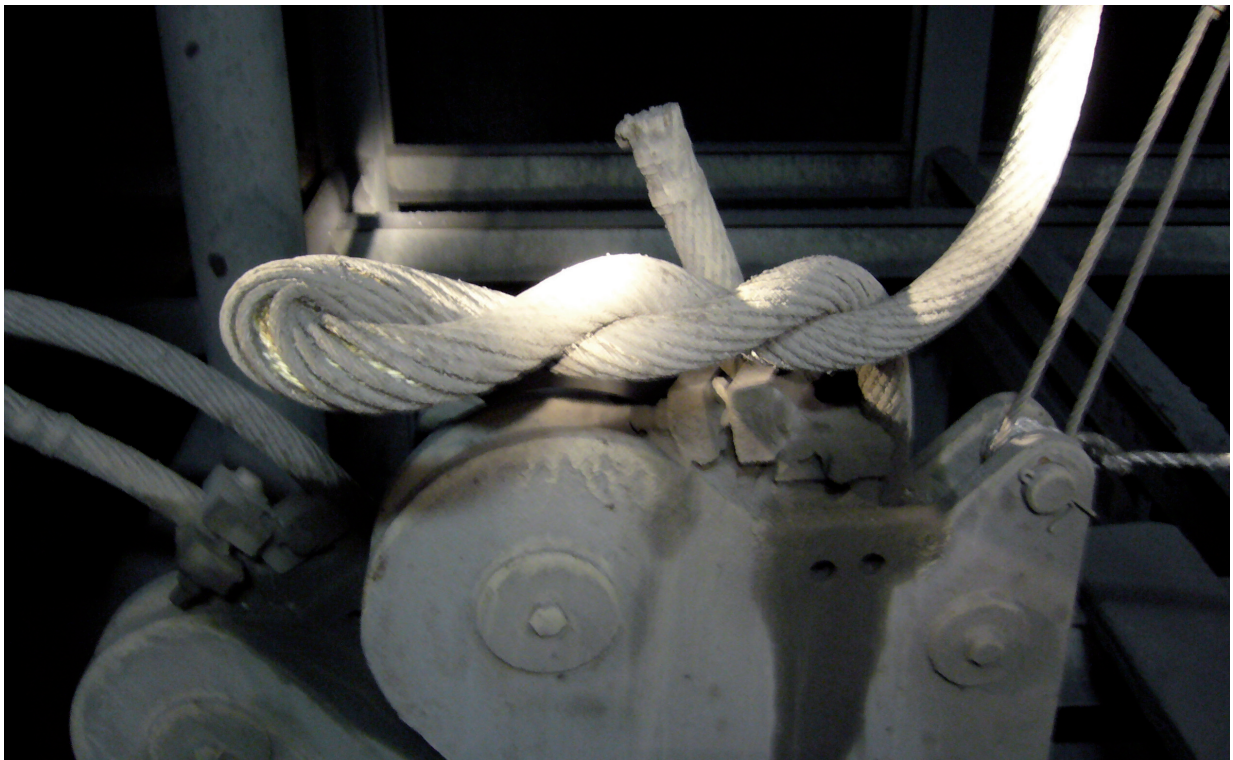
Fig. 22: A kink has formed above the conveyance of a deep shaft mine when the rope became slack.

This twisted state of the rope does not present a real problem during the operation of the shaft (although the fatigue life of the rope will be reduced). If, however, during an upward motion of the skip an emergency break occurs, the hoisting drum will stop turning while the skip continues its upward motion. As a consequence, the rope section just above the skip might become slack (Fig. 22) and, because of its twisted state, form a kink.

Ropes with variable lay lengths avoid the problems described here by producing the same rope moment under the low load above the skip as under the high load 2000 m higher. Therefore these ropes will not have to twist to find a state of equilibrium, and as a consequence work in a non-twisted condition. This improves the fatigue life while at the same time reducing the risk of a kink formation in a slack rope condition.
